Dendroarchaeological Investigations at Kiix'in National Historic Site, Vancouver Island, BC

Investigative Report of Wood Elements

UVTRL Report 2003-01

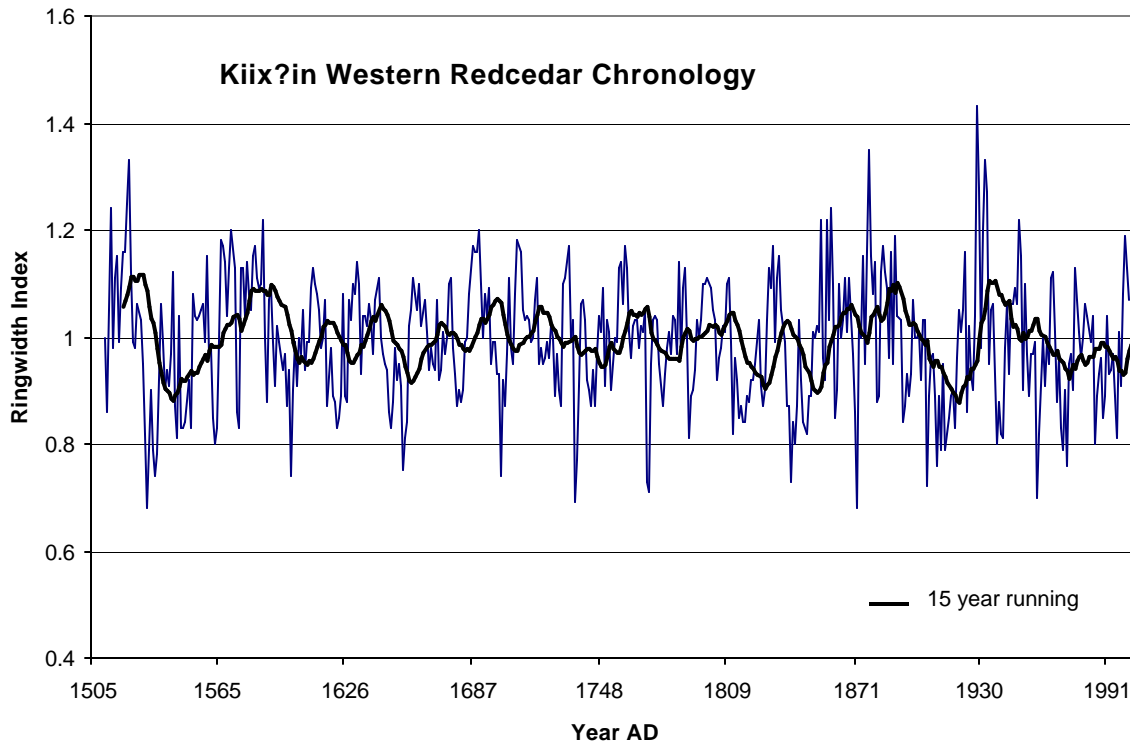
Figure 1. The Kiix'in Western redcedar master tree-ring chronology (1511 to 2002 AD). The 15-year running mean emphasizes extended periods of enhanced and reduced tree-ring growth.

The master chronology spans the interval between 1511 to 2002 AD (series correlation 0.431; mean sensitivity 0.168; autocorrelation 0.8). Growth trends in the early part of the Kiix'in Western redcedar chronology are quite variable and likely an artefact of the limited sample depth. Intervals of reduced growth rates occur from 1600 to 1650, 1690 to 1765, 1800 to 1820, and 1835 to the 1860's AD. Lesser episodes of reduced growth occur in the 20th century, from 1915 to 1930 and again in the 1970's. Notable intervals of above average growth occurred in the late 1600s, late 1700's, and early 1900's AD.

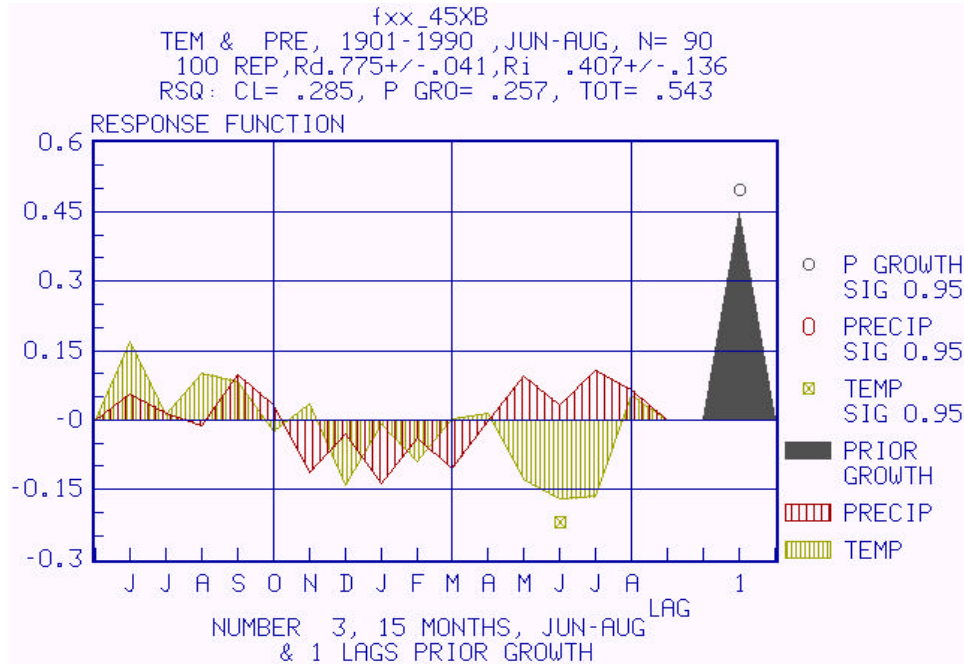
Figure 2. Response function analysis of the relationship between climate parameters and radial growth inherent in the Kiix'in Western redcedar master chronology. The analysis reveals a strong positive response to mean June temperature of the growing season. Of the 54 percent variation in annual radial growth explained by the climate response function, almost equal proportions are attributed to climate in the growth year and in the preceding year.

The Kiix'in Western redcedar master chronology was examined to confirm that climatic variables were responsible for limiting radial growth. Figure 2 shows the growth response of the Kiix'in redcedar master chronology to temperature and precipitation data from the Port Alberni climate station (1900-1990 AD). The figure illustrates the amount of variation in ring-width explained by temperature and precipitation over a 15-month interval, from June of the previous year to August of the growth year. A 15-month growth period was used to capture the annual growth signal, as coniferous trees are often influenced by growth in the preceding year. This response function analysis reveals a strong positive response to mean June temperature of the growing season. Of the 54 percent variation in annual radial growth explained by the climate response function, almost equal proportions are attributed to climate in the growth and preceding year. In the Kiix'in study, discovery of this climate-radial growth relationship validates the potential utility of the chronology for cross-dating purposes.

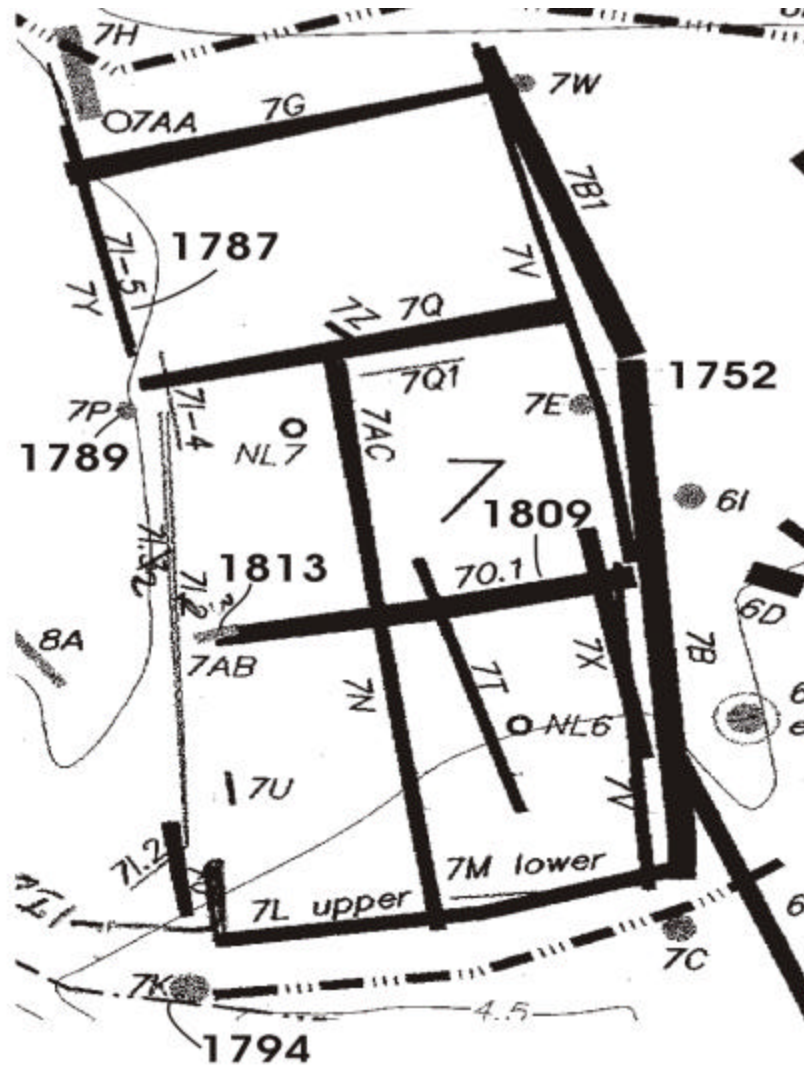
Figure 9. Outermost tree-ring age at Kiix'in bighouse

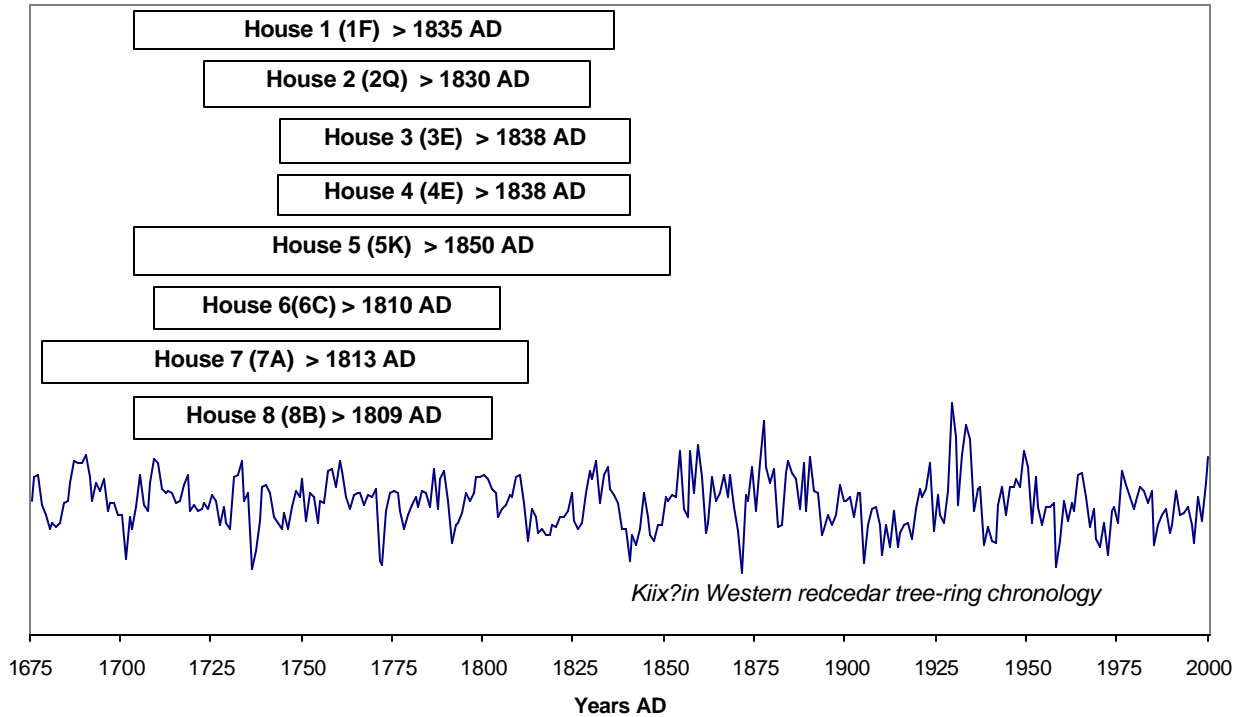
Figure 11. The duration and outermost tree-ring date of individual wood elements at each Kiix?in bighouse sampled in 2002. The dates assigned to bighouses 6 to 8 suggests they may predate the other structures by 20 to 25 years.

A dendroarchaeological survey of eight Huu-ay-aht bighouses at Kiix?in on Vancouver Island shows that they were constructed of Western redcedar trees felled in the 19th century (Figure 11). While this observation substantiates earlier findings, the perimeter dates established for several of the bighouses suggest that at least some of the structures were built somewhat later than previously suggested. This is certainly true in the case of Houses #1, 3, 4, and 5, where the outermost cross-dated tree rings date to greater than 1835 AD. As the amount of perimeter wood loss due to weathering and preparation is difficult to ascertain, no precise felling or construction date can be presented.

1. Recognition that Houses 6, 7 and 8 may predate the other structures by 20 to 25 years. While multiple cross-dates and Houses 6 and 7 seem to substantiate this conclusion, only a single cross-date supports this interpretation at House 8 (Appendix A).
