# Assessing Trail Degradation on the Hermit Trail, Glacier National Park, BC

Geography 477  
University of  
Victoria  
Fall 2008

Marissa Dempster  
Colin Mclean  
Claire Daniels  
Thomas Barucchi

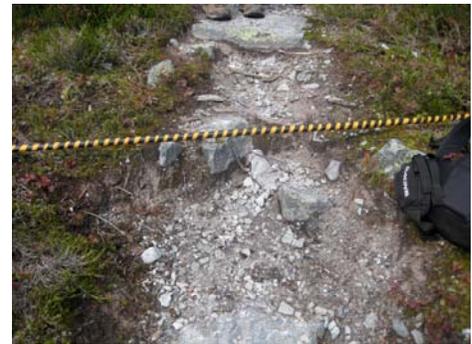
**Figure 3. Technique for measuring MI and CSA.**

At each sample point, a transect was established perpendicular to the trail and a series of measurements were taken (Figure 3.). The bare ground width (area free of living vegetation) was measured using a tape measure. The maximum depth of the trail was measured by running a pole across the trail, with both ends resting at permanent ground height. The distance from the pole to the tread surface was measured at three equal intervals along the width of the tread using a tape measure. The middle measurement was recorded as maximum incision (MIC), a reflection of the maximum amount of soil loss within tread boundaries, thus an indicator of soil erosion (Marion, 2006). The vertical measurements were also used to calculate the cross-sectional area (CSA) between the tread surface and the pole, the most common method for measuring soil erosion (Cole, 1983). In addition, these values were extrapolated to provide an estimate of total soil loss (Marion, 2006). The CSA was calculated using the following formula:

$$\text{Area}^1 = (V1 + V2) \times \text{Interval (I)} \times .5$$

$$\text{Area}^t = A^1 + A^2 + A^3$$

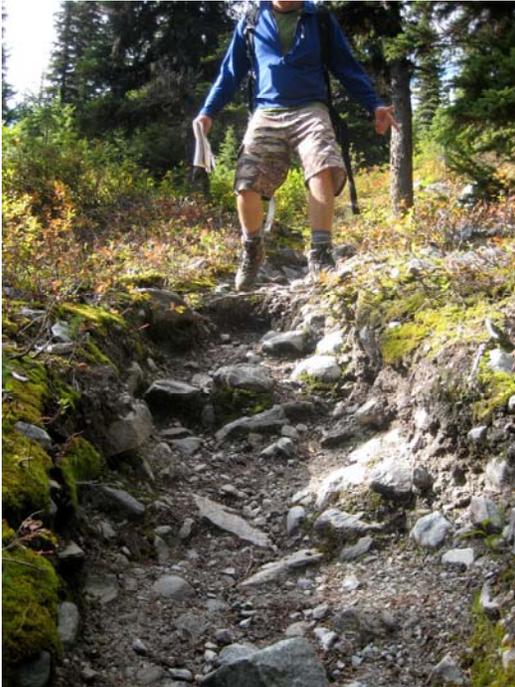
**Figure 5. Example of a severely incised portion of the trail**

Two measurements of erosion were used in this study, Maximum Incision (MI) and Cross Sectional Area (CSA). MI, or depth of the trail, was measured at each sample point with higher values indicating a higher degree of erosion. Incision values ranged from 3 to 24 cm with a mean of 12.8 cm (Table 3). Four sample points (28.6%) had

incision values less than 10 cm and the majority of points (9 sample points, 64%) had incision values <15 cm, considered lightly damaged by Marion, Leung and Nepal (2006). Only 2 sample points had an incision value >20 cm (24 cm for both sample points), considered moderately damaged by Marion et al (2006), however, these values are just below what is considered significantly incised (25 cm) by Cole (1983).

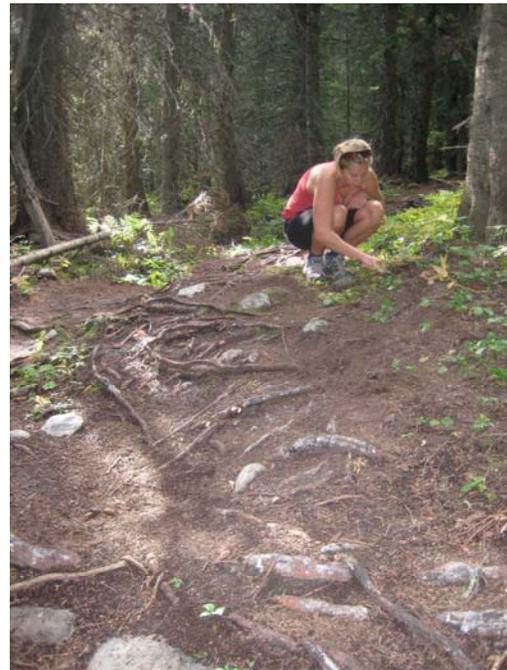
**Figure 6. Example of a wide portion of the trail with fairly severe root exposure**

Root exposure was measured at each site using four qualitative classes ranging from minor to extreme (Table 3). Four sample points (30.8%) had minor exposure; half of the points (50%) had moderate to extensive exposure and only one point (7.6%) had extreme exposure. The category labeled extensive represents fairly severe root exposure and therefore, should be taken into consideration for remediation. There were five points (38.5%) that have extensive or extreme root exposure.

Root exposure also played a large role in designating this trail as moderately damaged. One sample point (7.6%) exhibited extreme root exposure and five points (36%) were categorized as extensive, representing a relatively large portion of the trail. It should also be noted that the last 800 m of the trail, closest to the road, had vast amounts
