The August 1999 Debris Flow at Five Mile Creek, Banff, Alberta

An intense but apparently highly localized rainstorm triggered a debris flow in Five Mile Creek basin in the Front Ranges of the Canadian Rockies on 4th August 1999. In comparison to debris flow activity observed historically along transportation corridors in the Canadian Cordillera, the event was a large one, and it caused major disruptions to traffic and telecommunications in the Banff-Lake Louise area. Channel aggradation which occurred during the debris flow appears to have increased the level of future hazard at this site, as well as having increased the potential for sediment transport by normal streamflow. This sediment transport is now having significant negative impacts on highway infrastructure and nearby wetlands, forcing Parks Canada to seek a mitigative approach that attempts to balance hazard management with ecological objectives. The occurrence of such a significant debris flow event in Five Mile Creek basin, which has little if any evidence of debris flow activity in the past several decades, underscores the potential for such events in other relatively inactive basins in the Front Ranges.

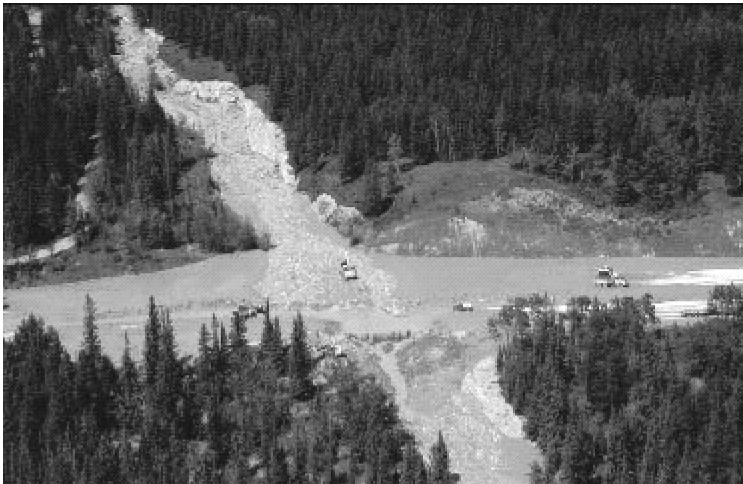
The main part of the debris flow travelled via the main active channel along the fan's northeast margin to the Trans Canada Highway, almost overflowing onto the fan surface at two locations. At a picnic site situated a short distance below the fan apex (see Fig. 3), a six-metre high wooden footbridge was dislodged and transported by the flow to the highway. The greatest disruption occurred at the highway, however, where an 8 m wide by 3.5 m high culvert was blocked with sediment allowing the debris flow to bury the highway (Figs. 5 and 6). The blockage was probably due in large part due to a boulder, reported by work crews to be "the size of a small car", that was lodged inside the culvert. The burial of the highway was gradual according to one eyewitness, probably accounting for the fact that no vehicles were trapped or damaged by the flow. Nonetheless, the Trans Canada Highway was closed for 20 hours, creating major traffic disruptions between Calgary and the British Columbia interior. The sediment deposits on the highway are estimated to have been up to 3 m in depth and covered the four lanes for a distance of 190 m. All four lanes were not reopened until late August.

Figure 5: Highway 1 closed by the debris flow, 5th August 1999. View is upstream from above the lower fan.

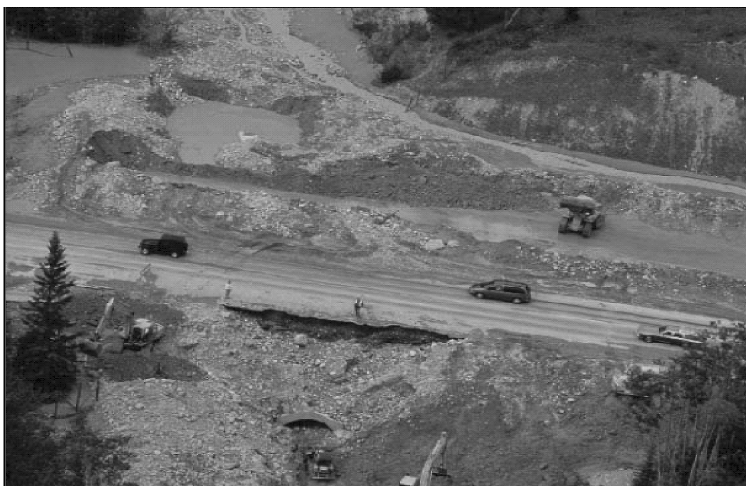
On the south side of the highway, the debris flow undercut a portion of the eastbound lanes, destroying buried telecommunication lines (Fig. 6). Immediately below the highway, the channel was

Figure 6: With the westbound lanes still buried by the debris flow deposit (top of photo) late on 5th August 1999, westbound traffic is being diverted via the eastbound lanes. The destroyed telecommunication line to Lake Louise is beneath the road edge where two individuals are standing.

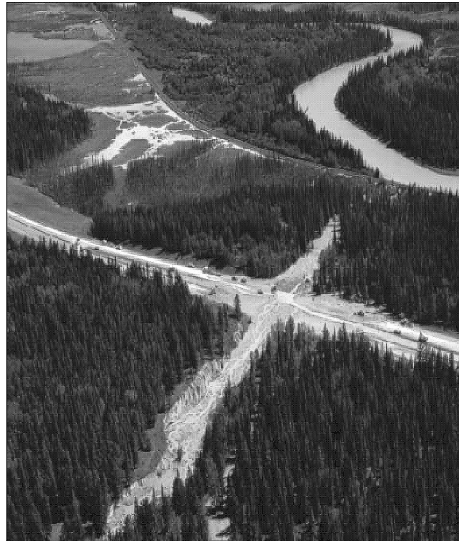
filled to a depth of five metres by sediment. The debris flow continued another 280 m to the CP Rail line at the fan toe, with fines washing through culverts into the Bow River (Fig. 7). The low gradient along this reach (approximately 2°) indicates the fluidity of the flow below the highway. Nevertheless, boulders up to one metre in diameter, large logs, and concrete barriers from the highway were rafted as much as 260 m below the highway, where they were dammed up behind a stand of mature conifers. Two culverts used to direct water flow from Five Mile Creek under the CP Rail line into the Bow River were completely blocked by finer sediment. Immediately after the event Five Mile Creek was diverted by work crews into the Vermilion wetlands (upper left corner of Fig. 7), until the main channel was excavated.

Figure 7: View east from above the upper fan on 5th August 1999, showing the debris flow deposit extending across Highway 1 to the CP Rail line adjacent to the Bow River. Five Mile Creek is being diverted into the Vermilion Lakes wetlands in the upper left of the photo.
